**Flood Control Project Maintenance
Levee Inspections**

Fall 2011 Levee Maintenance Deficiency Summary Report

Reclamation District No. 2107 Mossdale Island

Levee Inspection Report By Mile - Fall 2011

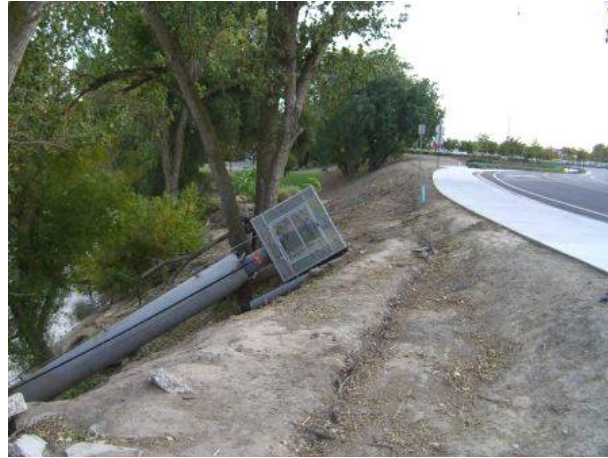
Levee Mile Report Line	1
Start Levee Mile	0.02
End Levee Mile	0.02
Location	Water Side
Category	Earthen Levee
Item	Vegetation

Fall 2011 Area has been cleaned and meets the framework guidelines for waterside vegetation.

LMR No.	Levee Mile		Category	Item	Location *	Rating **	Action/Comment	GPS Latitude/Longitude		Issue No.
	Start	End						Start	End	
1	0.02	0.02	Earthen Levee	Vegetation	WS	A	Remove the wild growth other than native grasses from the levee slopes. Inspector Comments: Vegetation has been cleaned and meets the criteria of the framework for waterside vegetation.	37.786911 ° -121.308708 °	37.786911 ° -121.308708 °	3 Y
2	0.03	0.03	Earthen Levee	Trim / Thin Trees	WS	N	Tree stumps.	37.786993 ° -121.308694 °	37.786993 ° -121.308694 °	1 Y
3	0.25	0.25	Earthen Levee	Trim / Thin Trees	WS	N	Tree stumps.	37.784316 ° -121.306498 °	37.784316 ° -121.306498 °	2 Y
4	0.37	0.37	Earthen Levee	Trim / Thin Trees	WS	N	Tree stumps.	37.783233 ° -121.305125 °	37.783233 ° -121.305125 °	4 Y
5	0.42	0.42	Earthen Levee	Animal Control	WS	C	No rodents visible, but rodent burrows visible; need to backfill and compact or grout burrows. Inspector Comments: Rodent burrows are in close proximity to Elderberry bushes on water side.	37.782666 ° -121.304329 °	37.782666 ° -121.304329 °	13

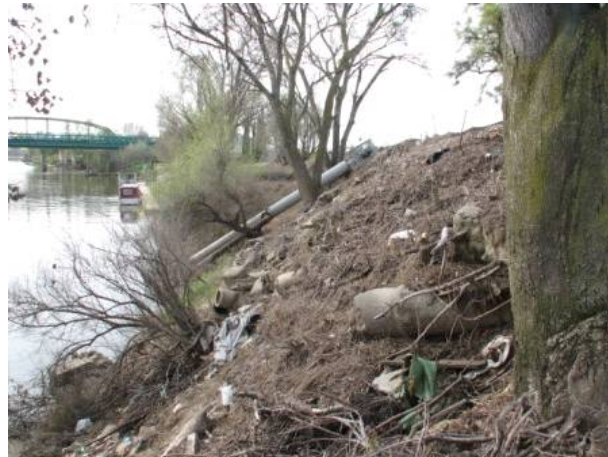
Levee Mile Report Line	2
Start Levee Mile	0.03
End Levee Mile	0.03
Location	Water Side
Category	Earthen Levee
Item	Trim / Thin Trees

Photo of waterside slope. Stumps present from prior tree removal for access and visibility.

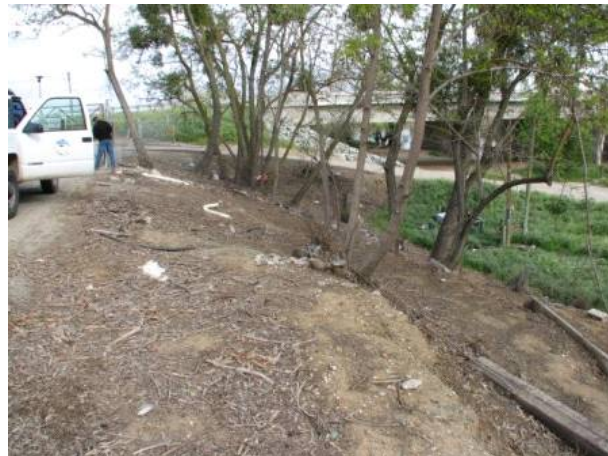
Levee Mile Report Line	3
Start Levee Mile	0.25
End Levee Mile	0.25
Location	Water Side
Category	Earthen Levee
Item	Trim / Thin Trees

Tree stumps present on slope. They were left from prior vegetation removal for access and visibility.

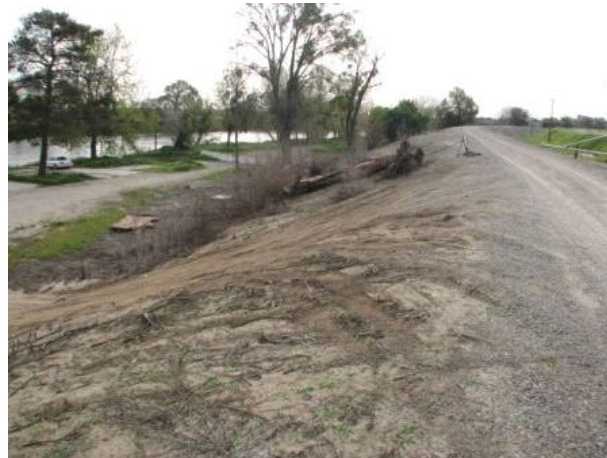
Levee Mile Report Line	4
Start Levee Mile	0.37
End Levee Mile	0.37
Location	Water Side
Category	Earthen Levee
Item	Trim / Thin Trees

Tree stumps and trunks on levee slope. Vehicle traffic on levee slope is an ongoing problem at this location due to the abandoned trailer park, access should be restricted.

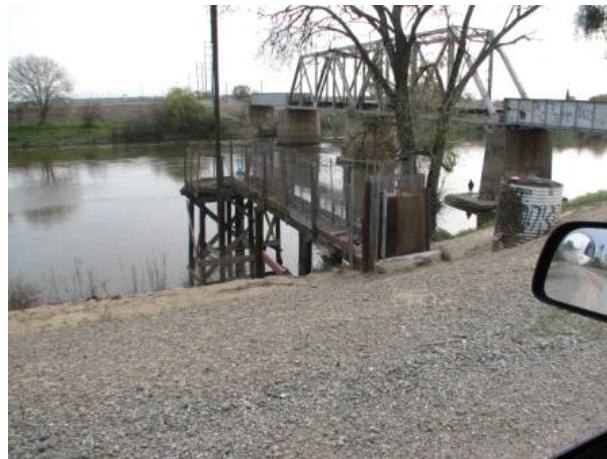
Levee Mile Report Line	6
Start Levee Mile	0.68
End Levee Mile	0.68
Location	Crown
Category	Earthen Levee
Item	Encroachments

Irrigation intake pipe runs through the base of the levee. Stand pipes on waterside and landside. A butterfly valve is located near waterside slope.

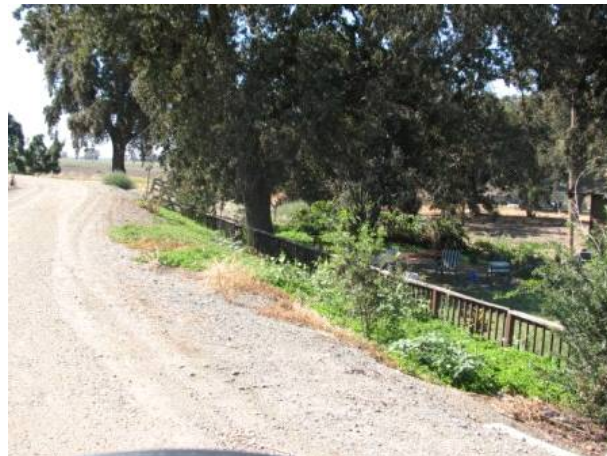
Levee Mile Report Line	10
Start Levee Mile	1.24
End Levee Mile	1.24
Location	Land Side
Category	Earthen Levee
Item	Encroachments

Fall 2009 photo of landscape planting on landside levee slope and a 3-ft yard fence at the levee toe.

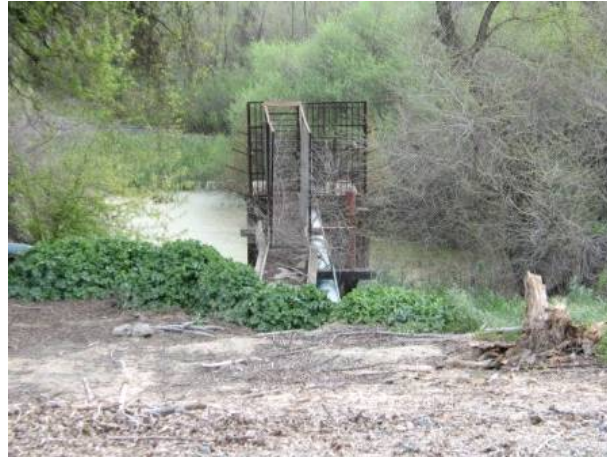
Levee Mile Report Line	11
Start Levee Mile	1.49
End Levee Mile	1.49
Location	Crown
Category	Earthen Levee
Item	Encroachments
Irrigation intake pipe through levee freeboard.	
jeto_f_20110923_465.jpg

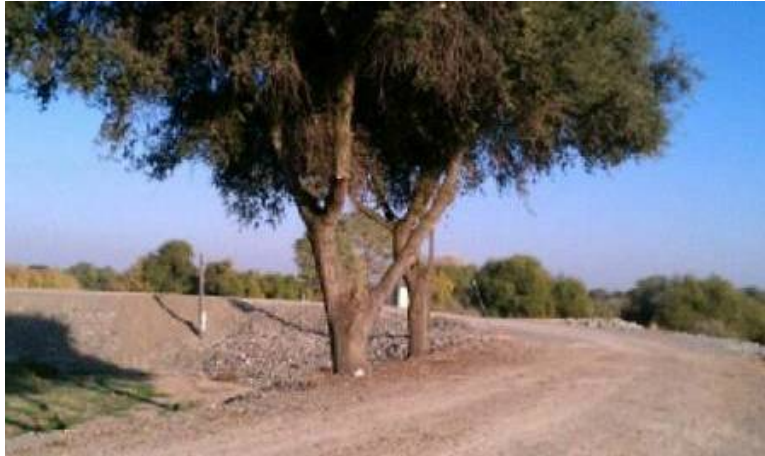
Levee Mile Report Line	1
Start Levee Mile	0.03
End Levee Mile	0.03
Location	Land Side
Category	Earthen Levee
Item	Trim / Thin Trees
Fall 2011 tree has been limbed up 12' over the roadway.	
jeto_f_20111121_623.jpg

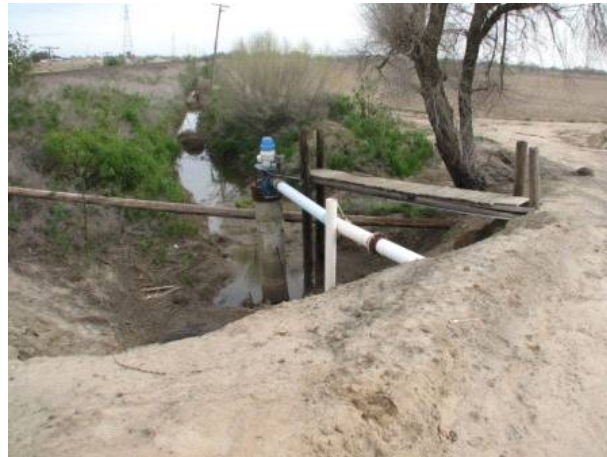
Levee Mile Report Line	3
Start Levee Mile	0.55
End Levee Mile	0.55
Location	Crown
Category	Earthen Levee
Item	Encroachments
Drainage discharge pump. Steel pipe penetrates levee freeboard. No flapgate on waterside. No closure device.	
jeto_f_20110923_474.jpg

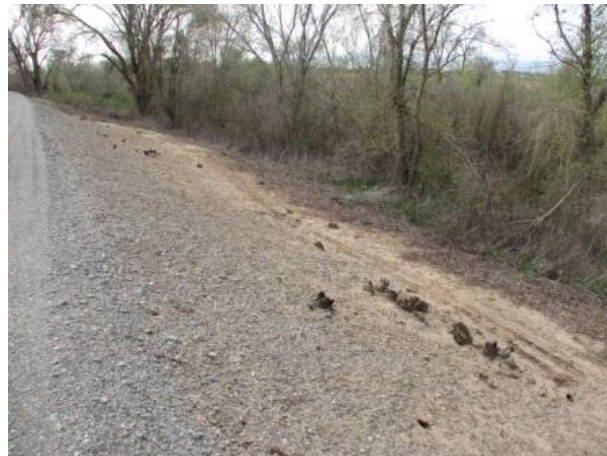
Levee Mile Report Line	4
Start Levee Mile	0.84
End Levee Mile	0.84
Location	Water Side
Category	Earthen Levee
Item	Trim / Thin Trees
Tree stumps on levee slope.	
jeto_f_20110923_475.jpg

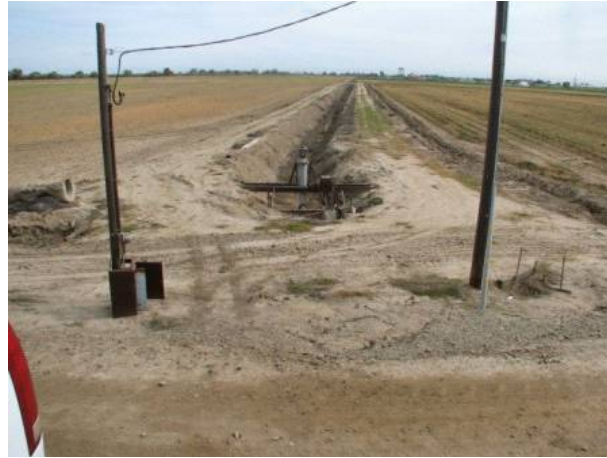
5	1.53	1.53	Earthen Levee	Encroachments	CR	W	Pipe Inspector Comments: Drainage discharge into Paradise Cut. Gravity flow and pressure flow from sump pump if necessary. Power to pump disconnected. Pump in disrepair. No flap gates or closure devices.	37.774170 ° -121.329954 °	37.774170 ° -121.329954 °	6 Y

Levee Mile Report Line	5
Start Levee Mile	1.53
End Levee Mile	1.53
Location	Crown
Category	Earthen Levee
Item	Encroachments
Drainage discharge pump inoperable. Parallel gravity drainage to Paradise Cut.	
jeto_f_20110923_476.jpg

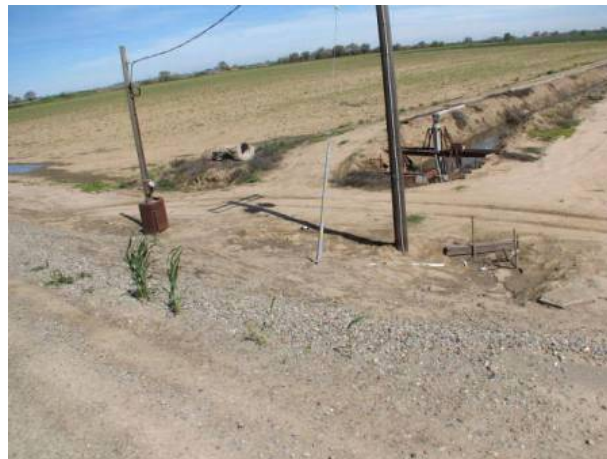
Levee Mile Report Line	5
Start Levee Mile	1.53
End Levee Mile	1.53
Location	Crown
Category	Earthen Levee
Item	Encroachments
03/30/2011 photo of Unit 2 gravity drain	
jeto_f_20110923_477.jpg
